## CEDIM Forensic Disaster Analysis Group (FDA)

### Volcano-Tsunami Anak Krakatoa

Information as of 2 April 2019 – Report No. 1

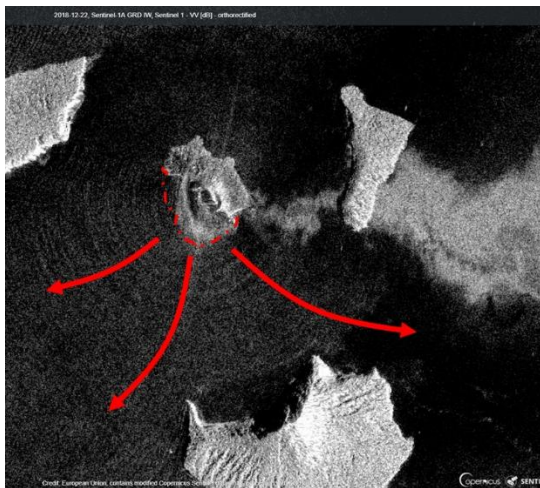
Anticipated movement direction of the tsunami-causing volcano landslide, imagery taken from sentinel-1a.

Anak Krakatoa is the successor volcano of the great Krakatoa which erupted in 1883. The volcano is known for its significant growth during the last decades. On Dec. 22<sup>nd</sup>, 2018, after a probable eruption of the volcano, parts of its South-Western flank slid into the ocean including an unknown underwater volume. This landslide triggered a tsunami which affected almost all coasts in the Sunda Strait within 30-50 min. Since the local time was in the early evening, the tsunami waves arrived at the coasts without great visual clues such as receding water leaving the people unprepared. In Lampung, the tsunami wave coincided with a high tide leading to an amplification. The wave pattern led to very local major inundations of up to 6m and 1-3m in a wider area.

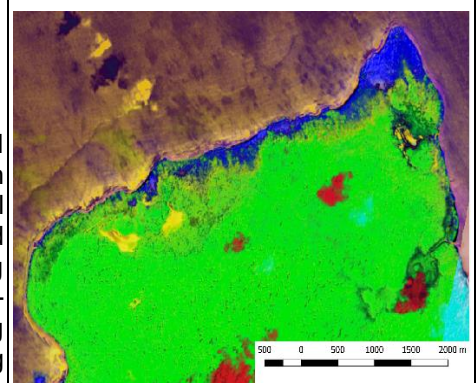
Description: *Local major inundation in Banten and Lampung, run-up of 1-3m (up to 6 at a few places).*

Inundation at Ujung Kulon, Banten indicated with blue colours, resolved from sentinel-2
