## **“Comparing the current impact of the Van Earthquake to past earthquakes in Eastern Turkey”**

**CEDIM Forensic Earthquake Analysis Group – Report #4**

**Status: Wednesday November 2nd, 2011, 18:00 Central European Time**

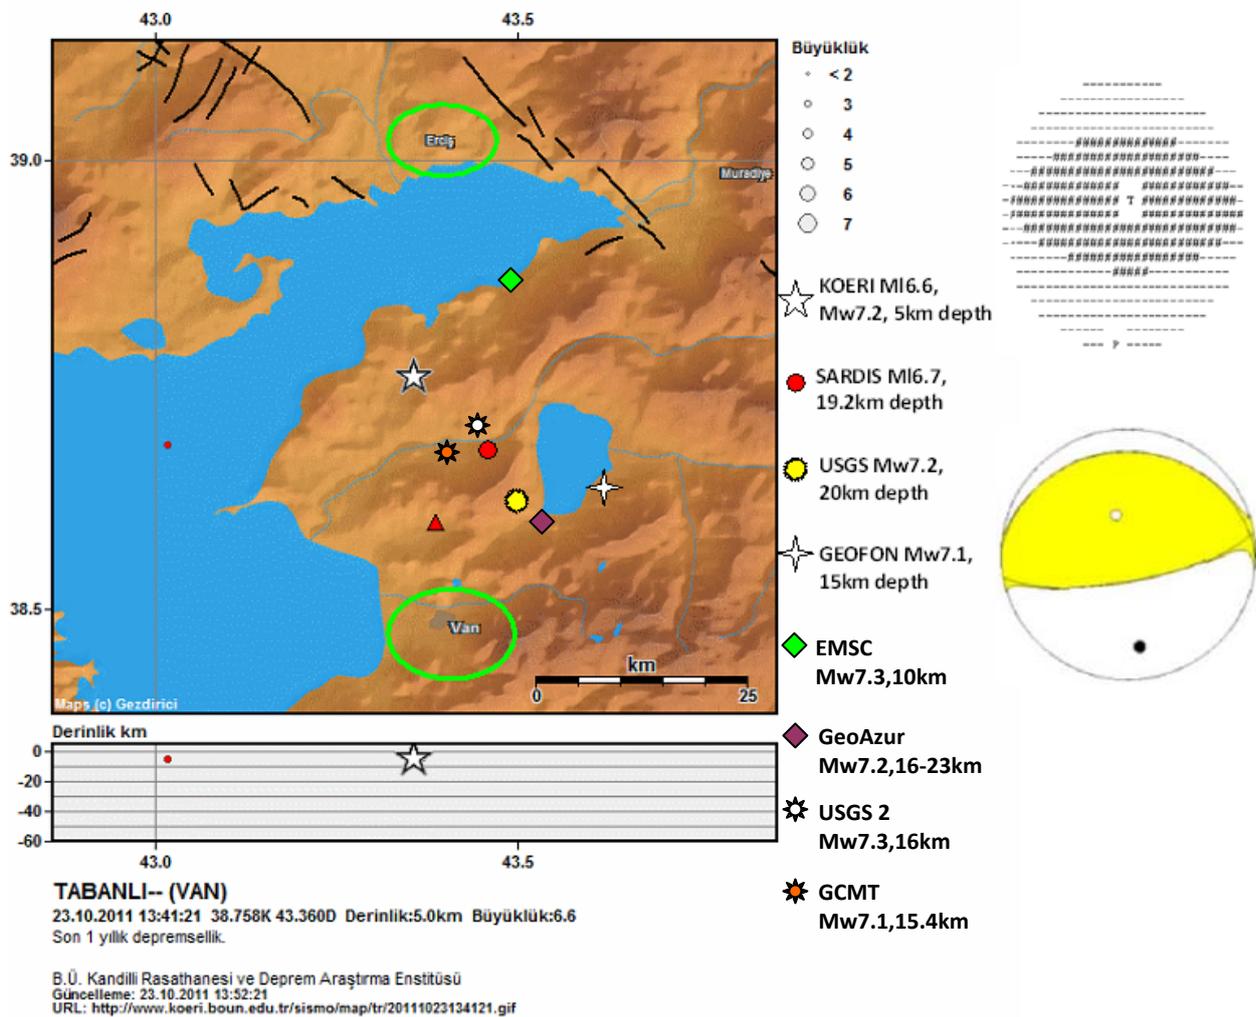
Figure 2: Hypocenters as determined from various agencies as compared to the large population areas of Van and Ercis (base picture courtesy of KOERI)

hypocenters from various agencies are shown on the following diagram. The KOERI hypocenter appears to correlate best to the damage seen.

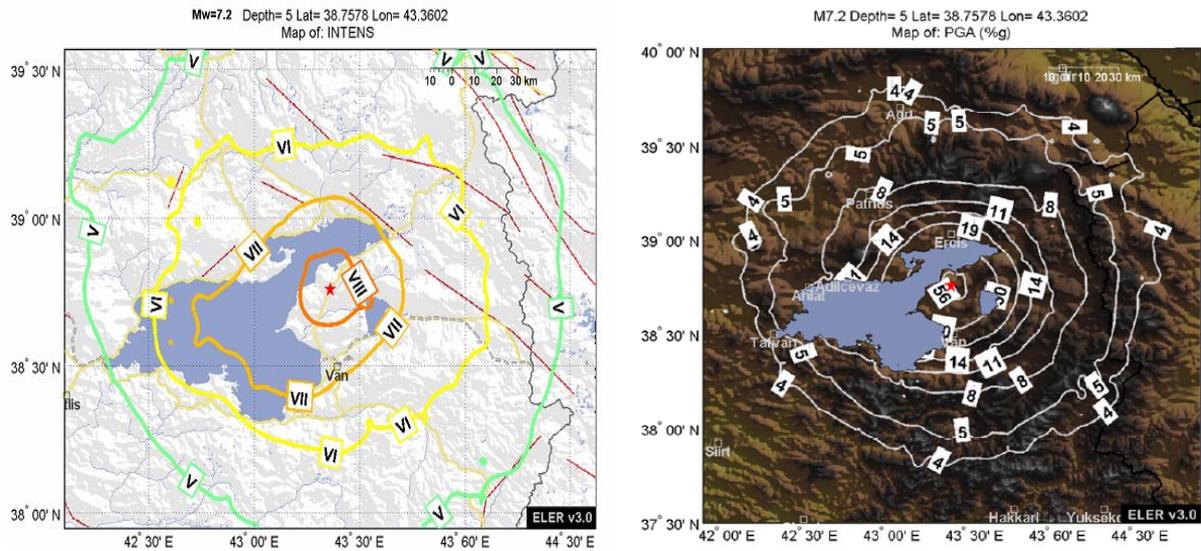
Figure 3: Courtesy of KOERI (<http://www.koeri.boun.edu.tr/>) – Intensities (EMS) (Left); PGA (%g) (Right)

KOERI shows estimates of PGA values modelled with ELER, including soil effects, but using a point source instead of an EW elongated rupture. Epicentral PGAs are estimated as  $550 \text{ cm/s}^2$ ; this should be essentially the value for Van and Ercis. The KOERI model is compatible with records of the Strong Motion Data Base of Turkey between 50 km and 120 km.

The ground motion at Muradiye and Bitlis was below the Turkish Design Spectra even for soft soil conditions (KOERI report 31.10.2011). In the epicentral area between Van and Ercis PGA values are estimated as  $550 \text{ cm/s}^2$ , three times higher than at Muradiye. The used ground motion prediction equation includes a 35% chance that the values exceed  $750 \text{ cm/s}^2$ . It is thus conceivable that ground motion, at least locally, exceeded code level.

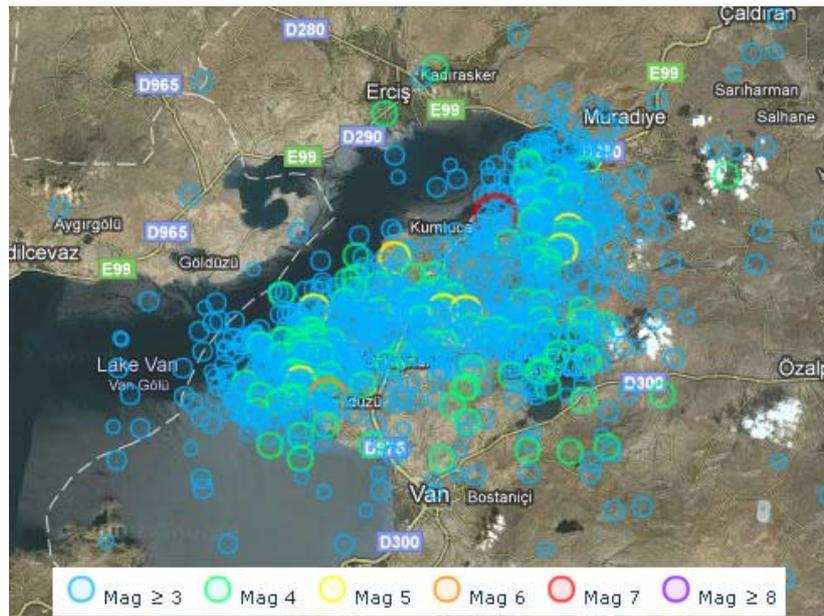
Figure 4: Aftershock distribution from EMSC representing 1128 aftershocks over  $M > 3$  as of 2<sup>nd</sup> November 2011 (Courtesy: EMSC, <http://www.emsc-csem.org/Earthquake/202/Earthquake-M7-2-Eastern-Turkey>)

The number of aftershocks between each magnitude bound are as follows: M2-3: 716 ; M3-4: 913 ; M4-5: 108 ; M5-6: 7; M6-7: 0. The approximate aftershock distribution can be seen in the last report.

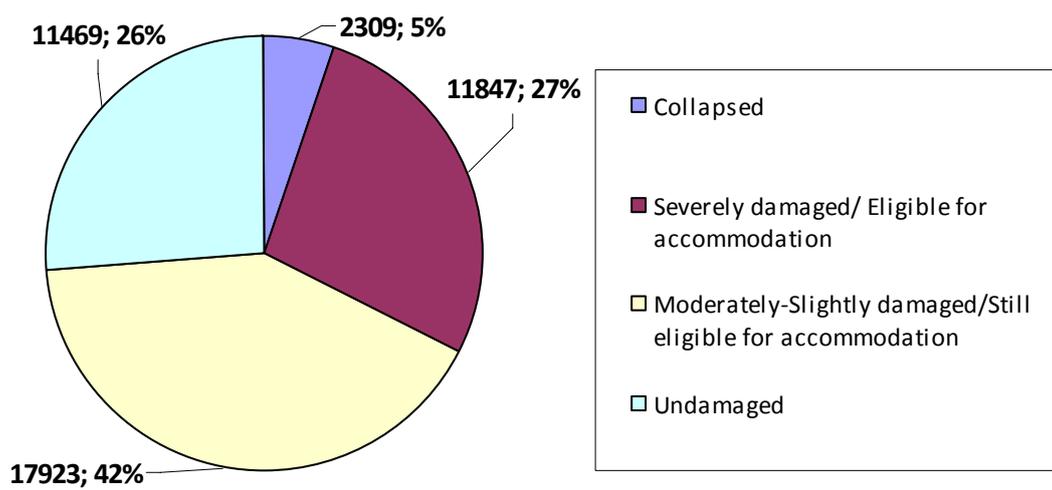
Figure 5: The current statistics of building damage as determined by different damage classes (TCRS details)

As of the 31st October 2011 reported from Turkish Red Crescent, from the 43,548 buildings that have been examined, 2309 have collapsed, 11,847 have been severely damaged or are uninhabitable. 17,923 houses have been slightly or moderately damaged. In addition, 11,469 buildings have been undamaged. A group of almost 200 staff has been undertaking preliminary assessment of the damaged buildings.

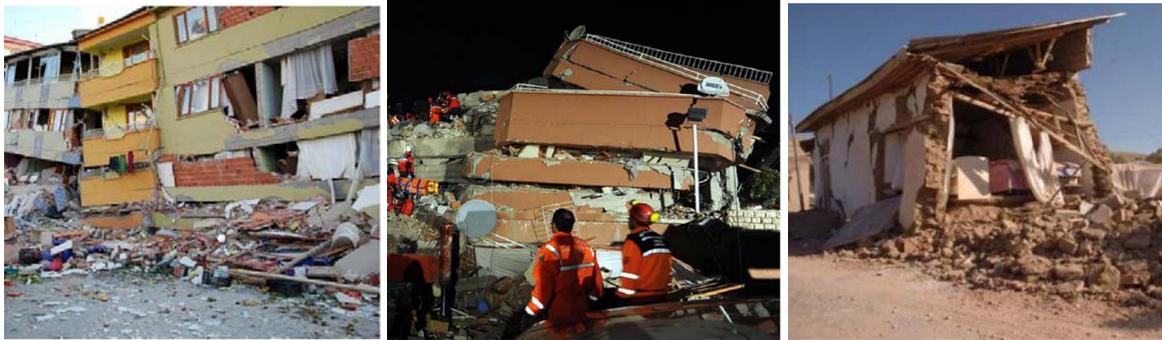
Figure 6: Soft storey collapse (left, gazetevatan.com); Pancake Collapse (central, fotogaleri.ntvmsnbc.com); Rural damage (right, gazetevatan.com)

Soft storey collapse regularly occurs in Turkish apartment buildings with the bottom storey having a higher storey height than the storeys above it, providing extra height for shops or for carparking. Concrete frame buildings with concrete flat slabs of three to seven stories collapsed in some cases around the urban centers of Ercis and Van.

Pancake collapse can occur where the columns of each level fail. Pancake collapses of the lower part and of the entire building and so-called outspread multi layer collapses can be seen in photos provided. As observed after the 1999 Izmit earthquake, many of the concrete floors did not remain intact within the collapse structures. Large voids in upper stories when only partly collapsed, but mostly very dense collapse structures lead to many casualties. This is the most fatal type of collapse with approximately 10x more injuries occurring in a total collapse, than in other forms of buildings beyond repair.

In addition, weak column-beam connections and weak building materials such as understrength concrete have had a huge impact on the building damage ratios. Lack of code enforcement may also have played a role, however more details are needed before commenting further. The 1998 (enforced essentially from 2000 onwards) and 2006 updates of the Turkish earthquake code have been integrated into modern buildings. Before that 10 other updates of various forms occurred for Turkish earthquake-resistant codes, however, not many in Eastern Turkey were enforced. From the CATDAT system, the building practice factor (a function of corruption, building practice, enforcement etc.) in this part of Eastern Turkey has a rating of 3.7/10, meaning that a reasonably high amount of non-code enforcement is expected. The seismic code index on the other hand is 8.5/10, indicating one of the best standards in the world for the relative hazard, when enforced.

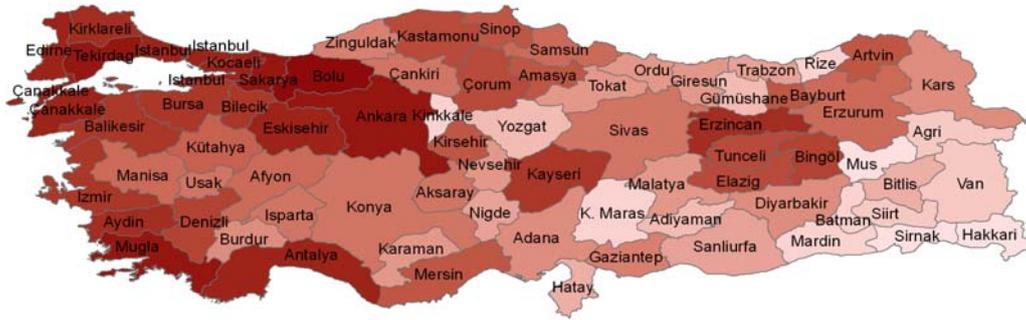
Policies as a percentage of buildings per Province

The number of sold policies was at 2.43 million in 2001 (19% of the insurable buildings), fell after this but grew again constantly since 2003 with fewer policies in the past two years. The average national insurance penetration is around 20% with notable differences across the regions and provinces. For instance the TCIP 2009 annual report indicates a 32.5% penetration in the Marmara Region, but only 13.7 in the East Anatolian Region.

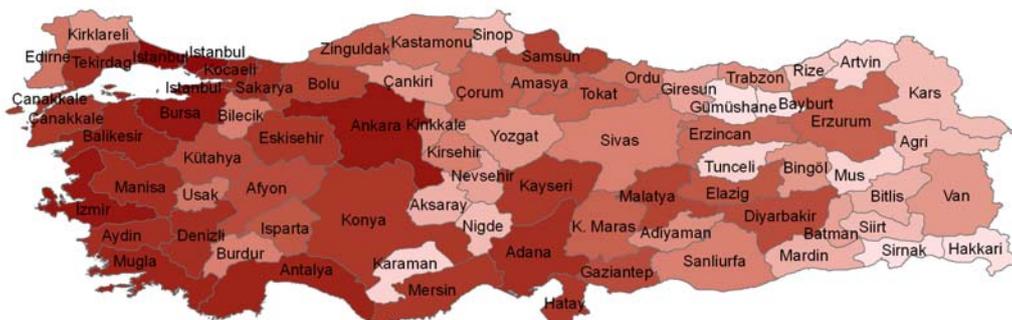
Premiums (USD) paid annually per province (\$198 million USD total - 2011)

The latest data from the Turkish Insurance Compensation Pool showed that in Bitlis there are 28,919 houses/buildings, of which 4047 have insurance (around 14%). The premium each year is 411,433TRY (228,000 USD). For Van Province (Ercis and Van cities) which is much more affected by this quake, for the 64,081 buildings, 7312 of them have TCIP insurance for earthquakes, **equivalent to 11.4%** with a 814,670TRY (453,000 USD) premium. Based on the 814,670 TRY premium (there is approximately a 400 million TRY (222 million USD) exposure).

Hakkari which was also affected has 16,314 houses/buildings with a much lower takeout of 1399 buildings; only 8.6%, with 144,469 (80200 USD) TRY premium.

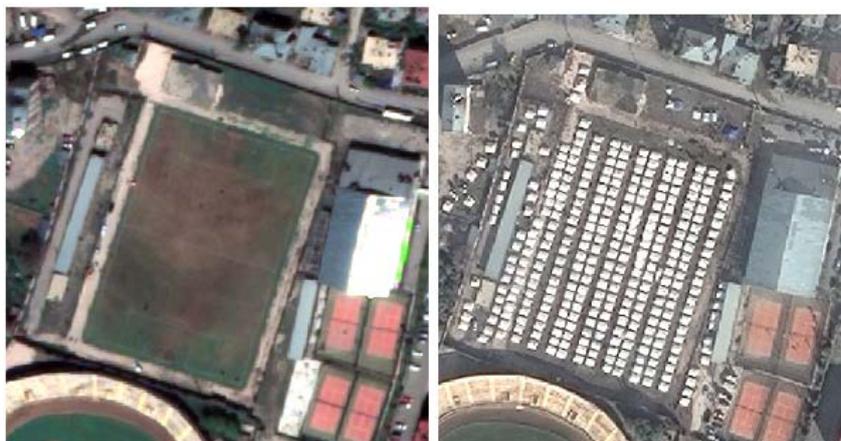
Figure 13: DLR – Center for Satellite Based Crisis Information – Tent City in Ercis Before (left) and After (right) (DLR, 2011)

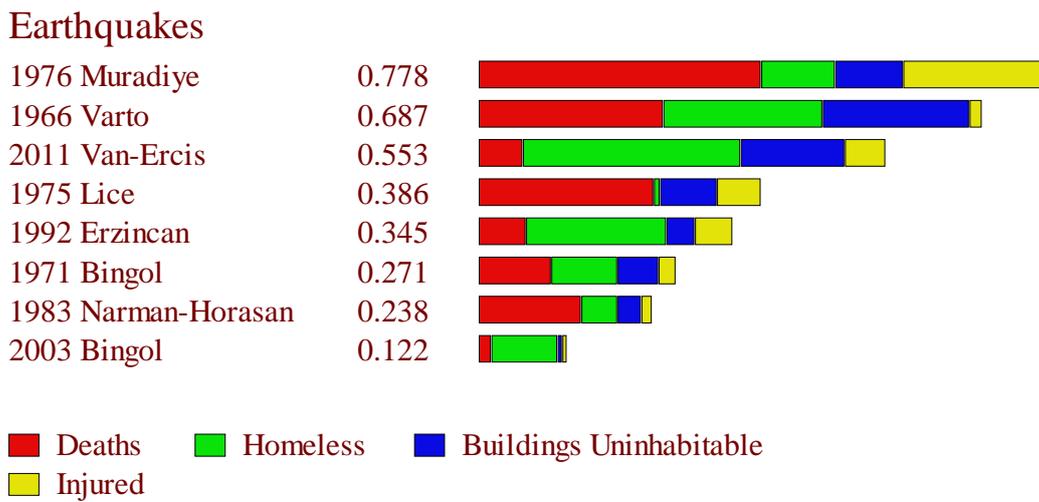
Figure 15: Loss score for historic earthquakes in eastern Turkey

A “loss score” for each of the 8 earthquakes is derived based on the weighted sum of several indicators of disaster impact in terms of physical damage (destroyed buildings) and human loss (death, injuries and homeless) and is shown in the Figure 4. A score of 1 shows the highest disaster impact in terms of the indicators used and a score of 0 the least. Using the latest information about loss figures from the 2011 Van-Ercis event, it can be seen that this event ranks as the third most damaging earthquake when compared with similar events in eastern Turkey in the past 50 years.

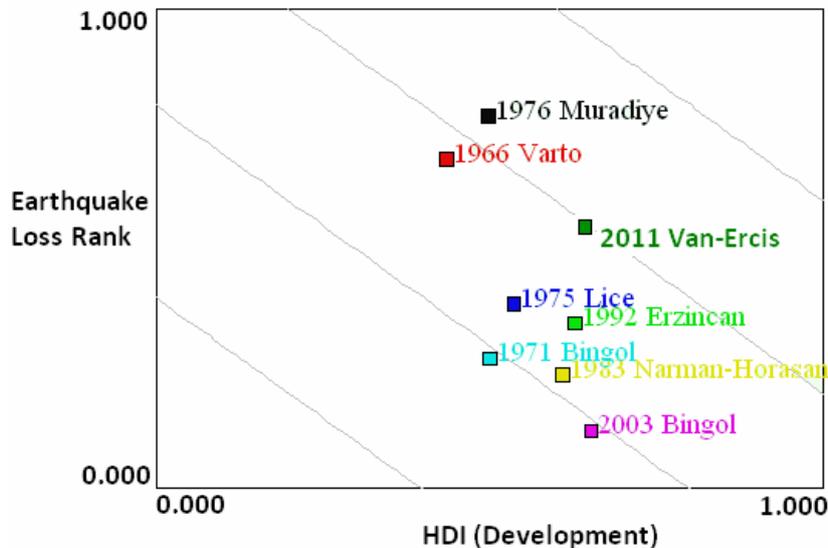
Figure 17: Scatterplot of Earthquake Physical Loss vs. HDI score for each of the provinces affected by the historic earthquakes in eastern Turkey similar to the 2011 event

Figure 17 shows a scatterplot with the Earthquake Loss Score shown on the vertical axis and HDI scores on the horizontal axis. The earthquakes in the bottom right have the least physical impact corresponding to higher capacities in the affected community according to the HDI values at the time of the earthquake occurrence, while the earthquakes in the upper left have the highest physical impacts corresponding with relatively lower capacities in the affected communities. It can be seen that the 2011 event has an impact greater than all but the 1966 Varto and 1976 Muradiye of the Eastern Turkey earthquakes in the last 50 years.
