# CEDIM Forensic Disaster Analysis Group (FDA) Flooding in Venice, Italy

Information as of 19 November 2019 – Report No. 1

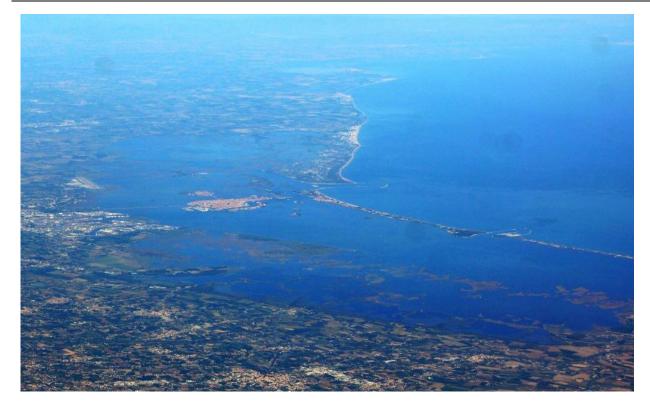
**Figure 2**: Aerial view from the southwest across the Venice Lagoon. The city of Venice is located left of the image centre. The upper right of the image shows the north western Adriatic Sea. Photo: B. Mühr

The MOSE system (mobile barriers for the protection of Venice from high tides) shall provide flood protection. The mobile barriers can close the three inlets which allows to separate temporary the lagoon from the sea in an event of high tide (Figure 2). The first construction work began in 2003, but MOSE is not expected to become operational before 2021.

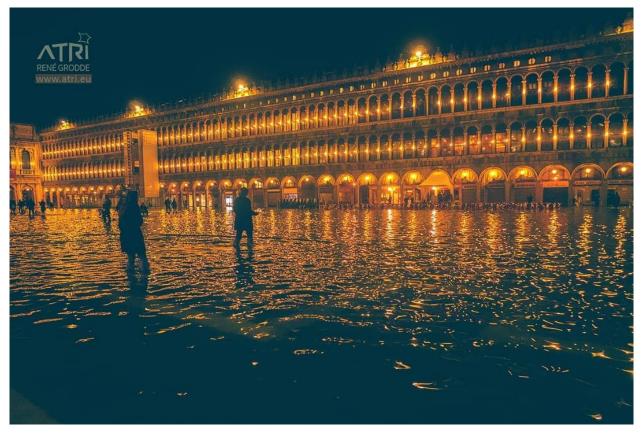
Figure 8: Photo of the flooded Piazza San Marco at night. Photo: René Grodde, www.atri.eu

Around 87% of the total area of the historic city centre was under water (Figure 8). According to the mayor, the damage amounts to several hundred million euros. Damage occurred not only around the world-famous Piazza San Marco, but also to numerous monuments, shops and residential buildings throughout the city. According to the Italian Minister of Culture, more than
